Master Plan

Granite Creek Corridor Enhancement City of Prescott, AZ WPF1908, Task 5

January 2020

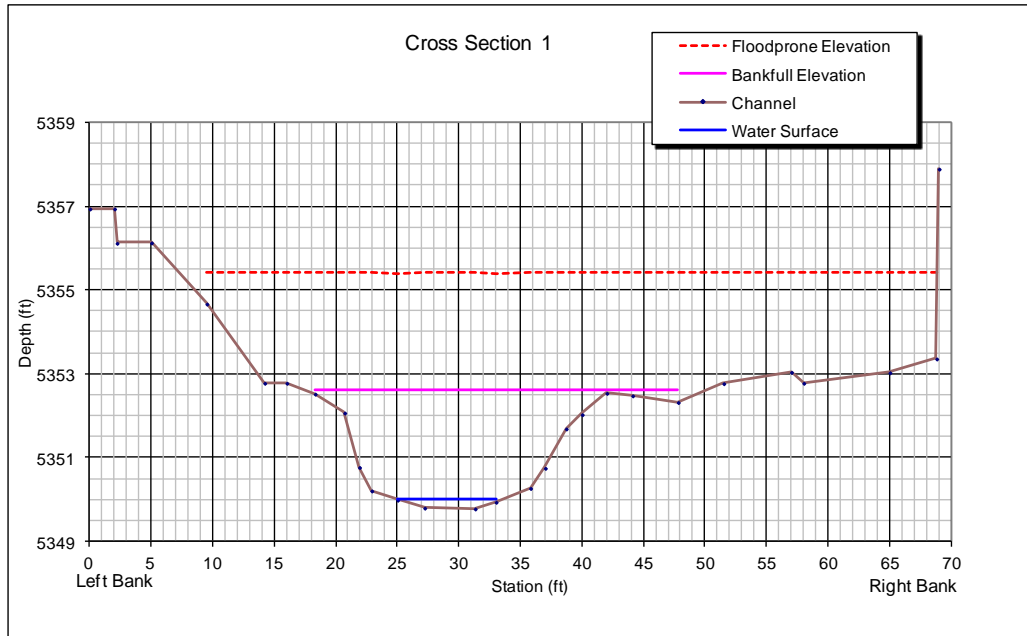
Figure 3. Cross Section 1.

This channel cross section represents a typical cross section, with relatively wide flood-prone area for the study reach.

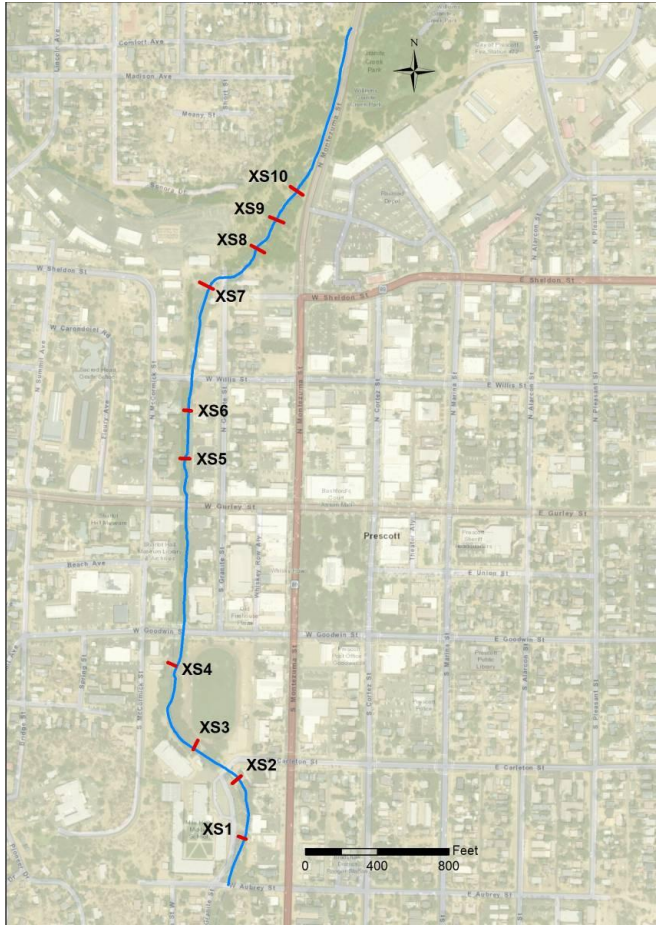
Cross sections 2, 7 and 10 were taken in pools, not riffles. Pool cross sections are not used as reference.

Figure 4. Location of channel cross sections.

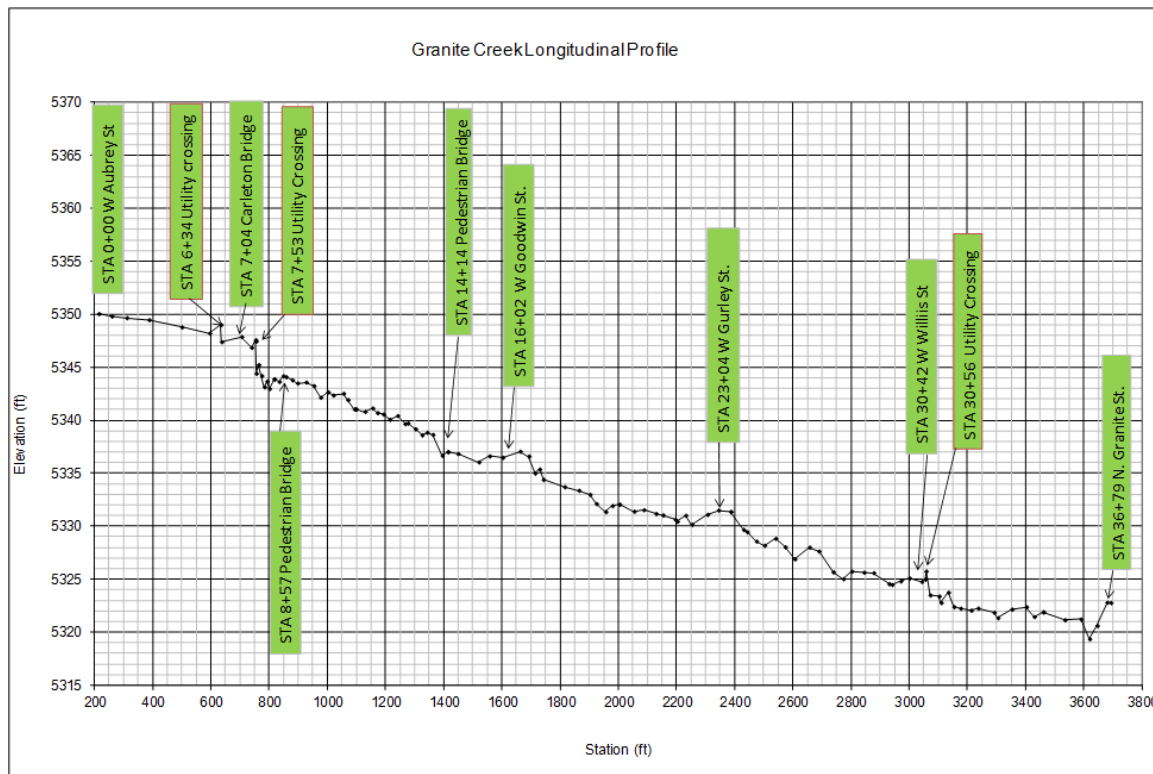
A longitudinal profile was surveyed starting at Aubrey Street and concluding at the trestle bridge (Figure 5). The profile shows an average gradient of 0.77% starting from Carleton Street Bridge down to Granite Street. The profile shows a riffle-pool sequence with utility crossings, bridges, and roads that serve as grade control; lowering the upstream grade and creating pool habitat.

Figure 5. Longitudinal profile through the project site.

Specific channel features are located along the longitudinal profile. Armored utility crossings are currently acting as grade control for the channel rather being buried below the channel bed.

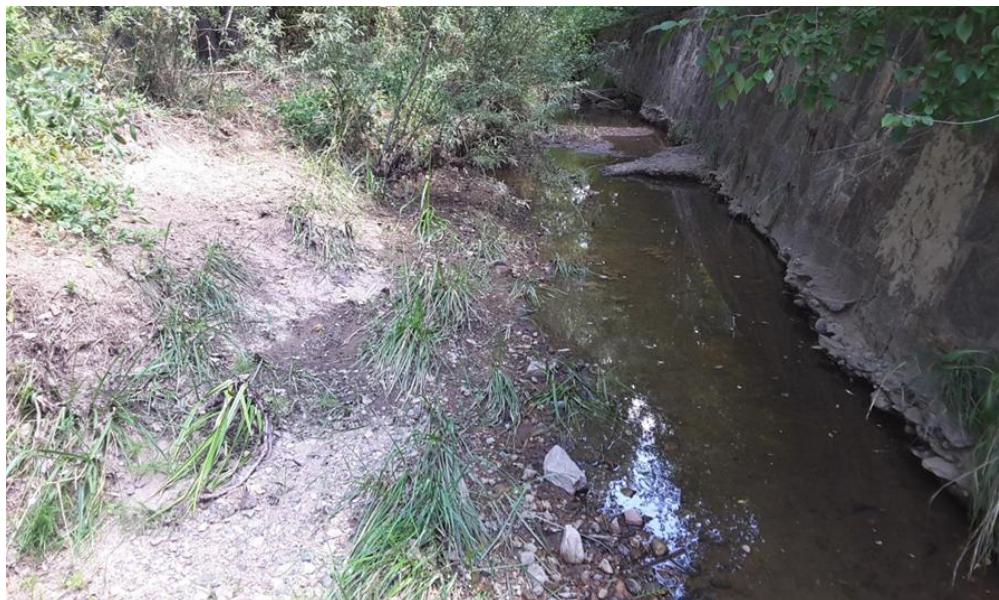
Figure 6. Bed scour undercutting retaining wall where floodplain is overly narrow.

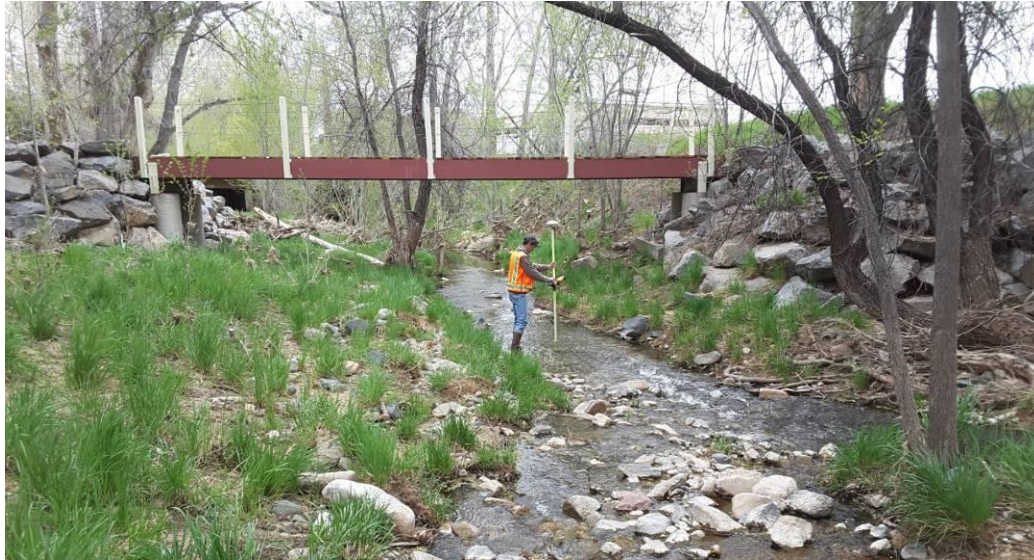
Bridge piers and other hard infrastructure in the corridor generally span the entire corridor, with the exception of middle piers. Consequently their capacity to carry flood flows is near the capacity of the corridor in general. However, there is a pedestrian bridge (upstream or south of Goodwin Street) with a riprap ramp that narrows the floodplain (Figure 7). This situation is ameliorated by the gap on the west side of the ramp which allows flood flows to spread onto

the remaining floodplain. The other pedestrian bridge further upstream in the reach spans the entire floodplain.

Figure 7. Pedestrian bridge upstream from Goodwin Street.

The footbridge upstream of Goodwin Street has narrowed the floodplain. If it is replaced in the future it should be replaced with a longer span and the supports and rip-rap narrowing the channel removed or replaced with a vented-ford low-water crossing.

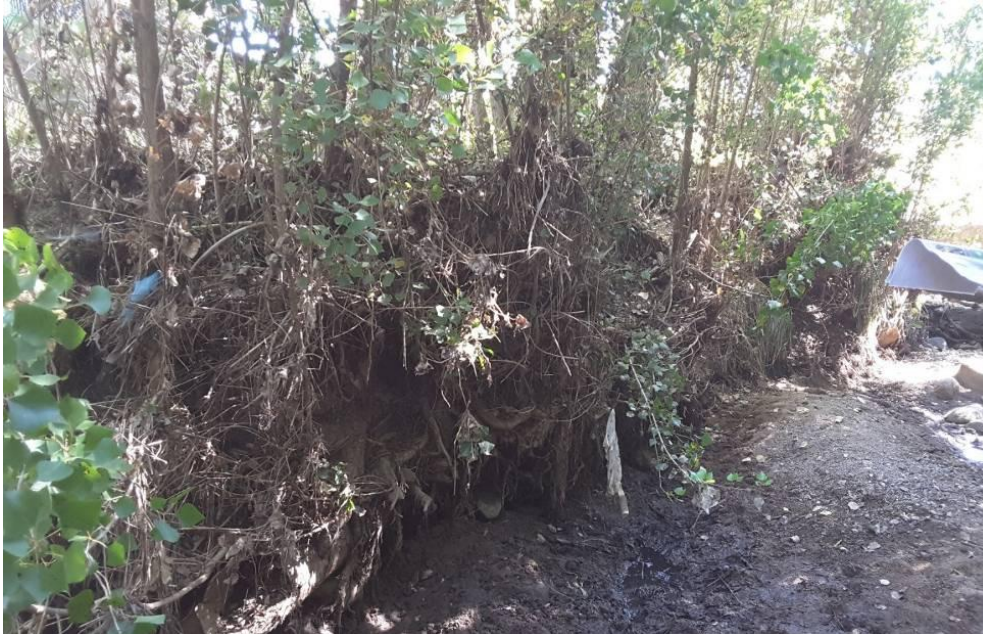
Figure 8. Dense tree roots holding channel shape.

Note the flood debris captured by dense, inflexible species.

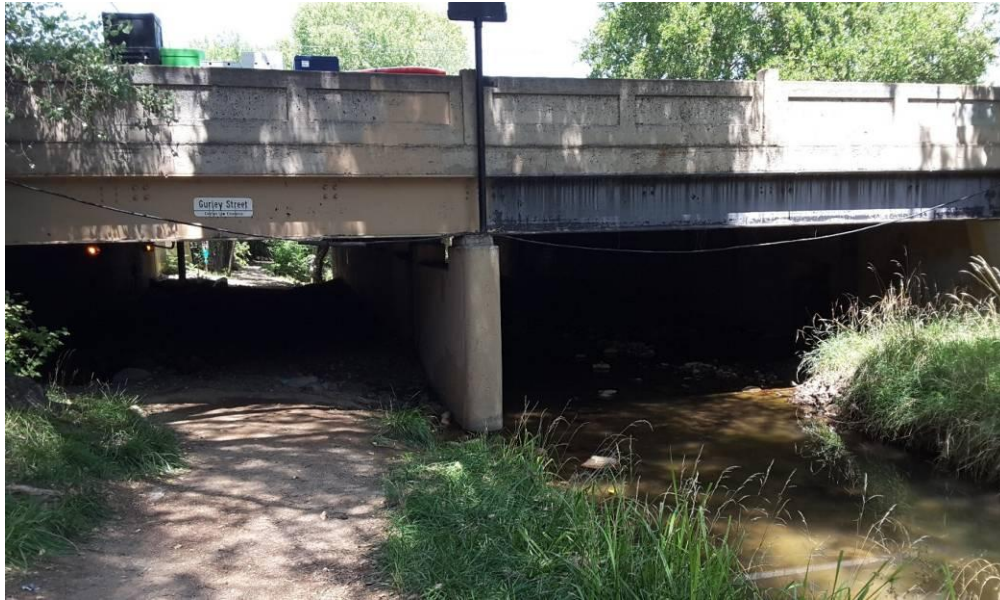
Figure 9. Gurley Street bridge

The pedestrian trail crosses beneath the bridge on the left. The bar on the left has been deposited by the stream during normal geomorphic activities.

The trail under the Goodwin and Gurley Street bridges is problematic for several reasons. The height under the bridges is inadequate, around six feet in some areas. Lowering the trail elevation will only lead to constant maintenance issues as Granite Creek seeks to rebuild the floodplain back to the current, stable geomorphic elevation. Also, normal flooding leaves rocks and debris on the trail surface which cannot be avoided since this is part of the floodplain function. A hardened trail surface under the bridges at the current floodplain elevation would provide an easier surface to maintain, would provide a guide for cleanout, and may prevent larger particles from settling on the trail during floods.

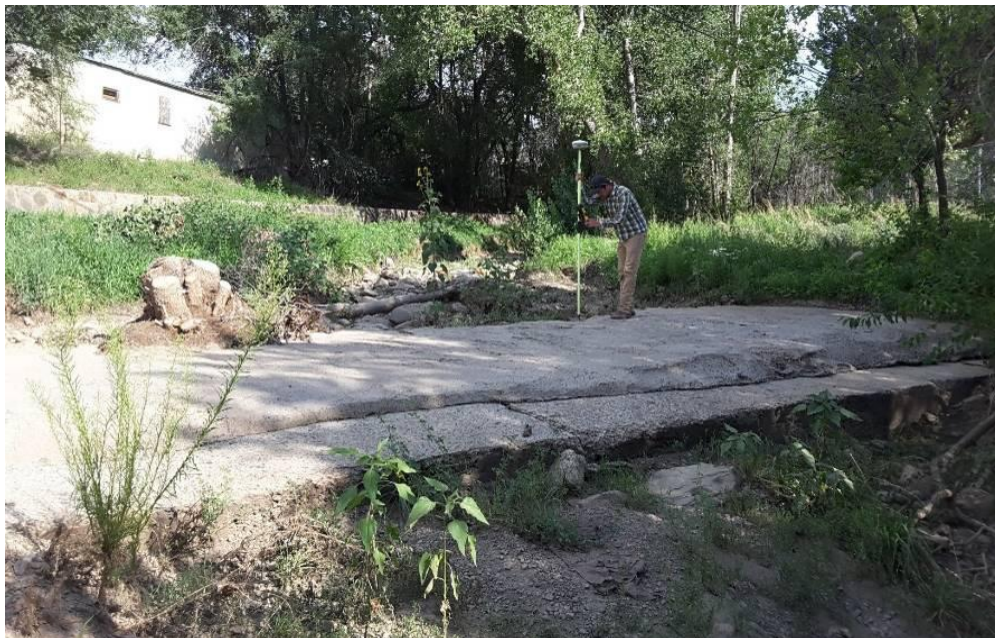
Several utilities cross Granite Creek at or above the grade of the channel bed. Most crossings now provide grade control as they have become exposed. The wide, flat cross section creates an overly wide stream channel, eroding banks on both sides and limiting sediment transport (Figure 10).

Figure 10. Utility crossing creates an overly wide, shallow cross section.

The overly wide section easily aggrades upstream and creates bank erosion on either side of the stream and bed scour downstream.

The riparian assessment indicates that seven (7) cross vanes should be utilized in the reach to protect existing infrastructure, redefine channel width and depth, and prevent incision of the active channel along retaining walls (Figure 19). Locations for weirs include the utility crossings under Aubrey Street, just up and downstream of Carleton Street, under Willis Street, and under the railroad trestle bridge. All of these crossings are currently creating an over-wide channel and most are directing the flow toward the bank. Placing a cross vane weir below the utility crossings will provide grade control and re-center the flow in the channel helping to ensure that the channel remains stable in these locations. The downstream crossing at Carleton Street has a three-foot drop below the crossing, which will likely require a three-step weir. Cross vane weirs should also be placed at the downstream end of the retaining walls that are being undermined by channel bed erosion.

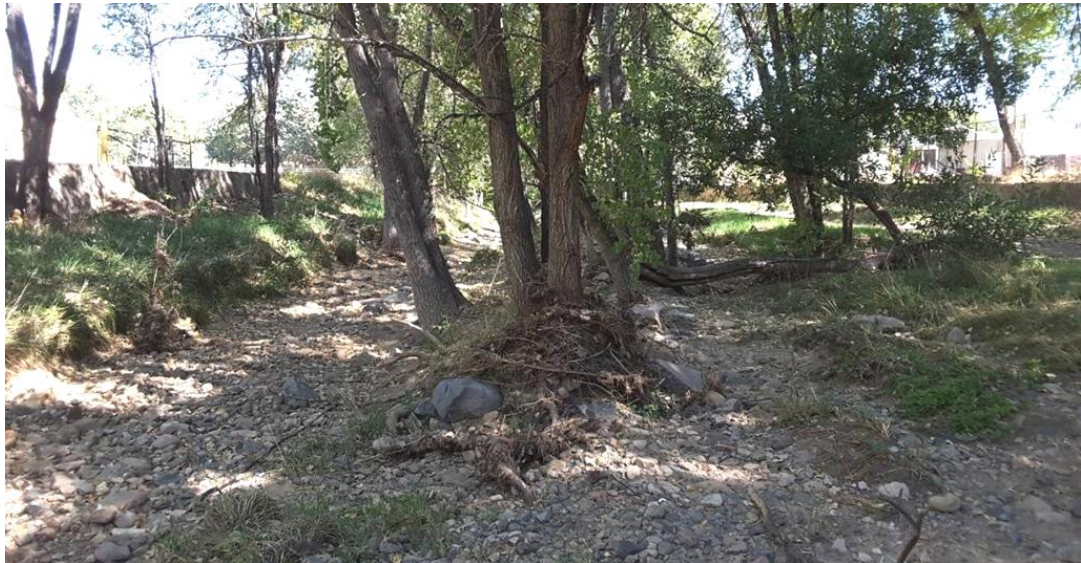
Granite Creek has many medium and large trees growing in the active channel where we would expect more flexible vegetation. Some of these are beautiful native trees providing shade, habitat and bank protection and should not be removed even though they are in the "wrong" zone. However, many of them are invasive or causing problems including an increase in bank stress, split channels, debris jams, and floodplain blockages and, in these circumstances, should be removed. Additionally, some of the larger trees are in need of maintenance to prevent falling limbs and in some cases entire trees as these trees age. There are also a few areas of very dense vegetation, where small trees and shrubs fill the entire floodplain leaving only a narrow channel.

Figure 12. Split channel caused by trees growing in active channel downstream from Aubrey Street.

There is approximately 500 feet of channel that is split into two or more channels. This is caused by trees growing in the active channel forcing water to flow around them. This increases

bank erosion, catches debris, which can cause debris jams and reduces the flow capacity of the channel.

The native trees growing between the split channels should be thinned, but some can be retained, especially those further from the main channel and any that are unlikely to cause bank erosion or debris jams. In some areas, the main channel can be easily shifted further away from the split channel to allow retention of larger native trees. Native shrubs should be planted along the main channel to provide bank protection.

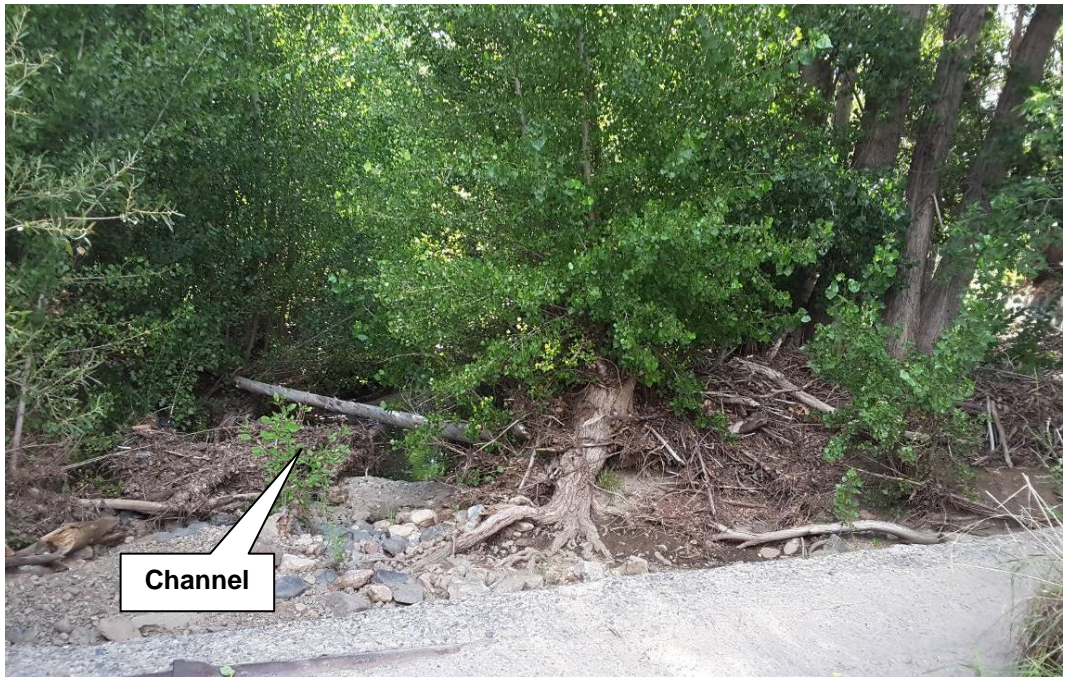
Figure 13. Dense vegetation blocking floodplain downstream of Carleton Street.

- Remove larger native trees from the channel bed, toe of bank, and lower floodplain where they are causing or likely to cause an increase in bank stress, bank erosion, split channels, debris jams, and floodplain blockages.

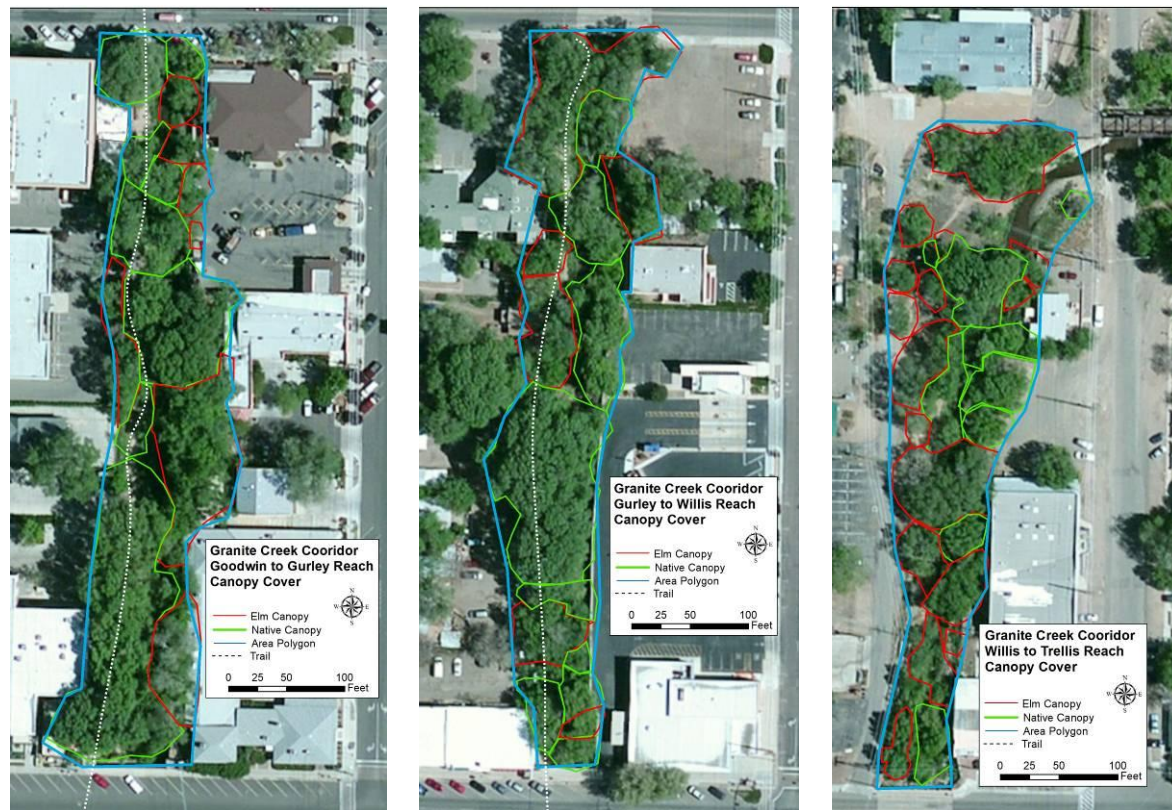
Siberian Elm (%)	Native Trees (%)	Open (%)
Reach 1	Aubrey to Carleton	50	28	22
Reach 2	Carleton to Goodwin	36	48	16
Reach 3	Goodwin to Gurley	30	61	9
Reach 4	Gurley to Willis	37	52	11
Reach 5	Willis to Historic Bridge	44	26	30

Figure 15. Reaches 3-5 canopy coverage.

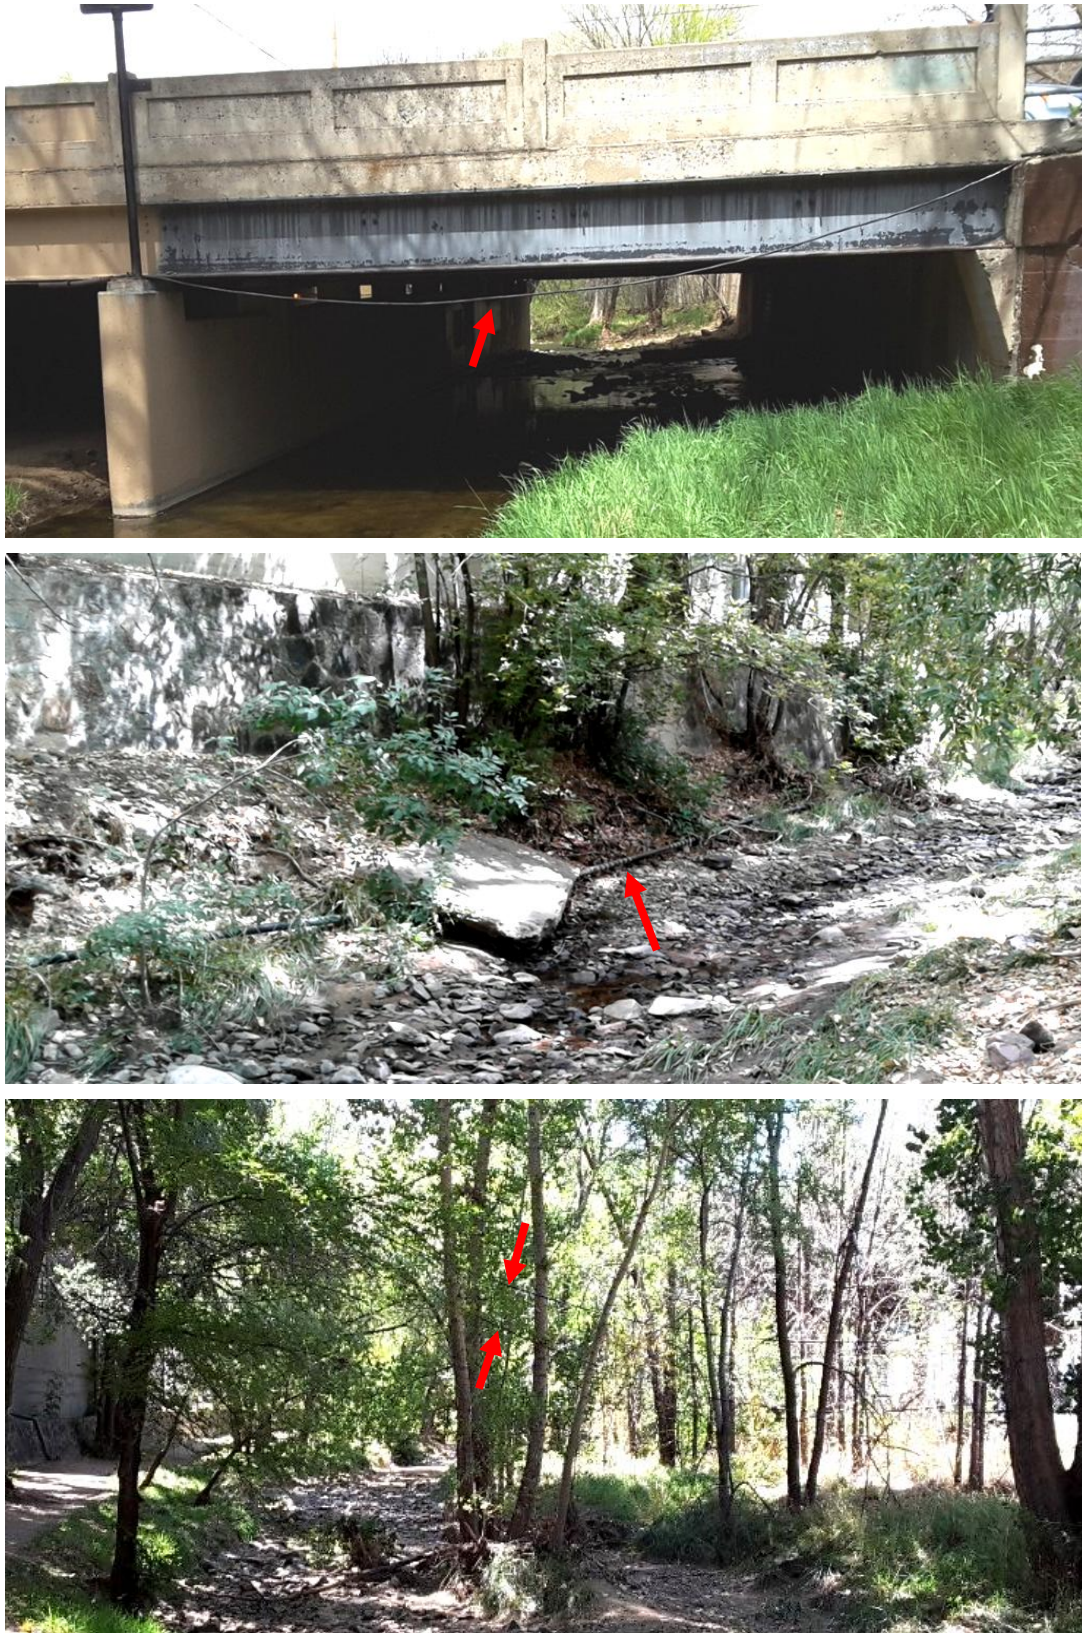
There are numerous utilities, wires, and pipes visible throughout the corridor. Some cross under Granite Creek as mentioned previously and some other major utilities cross over the creek at the bridges. A few smaller installations appear haphazard and not professionally installed and others appear abandoned.

Figure 16. Utilities that may be in need of repair.

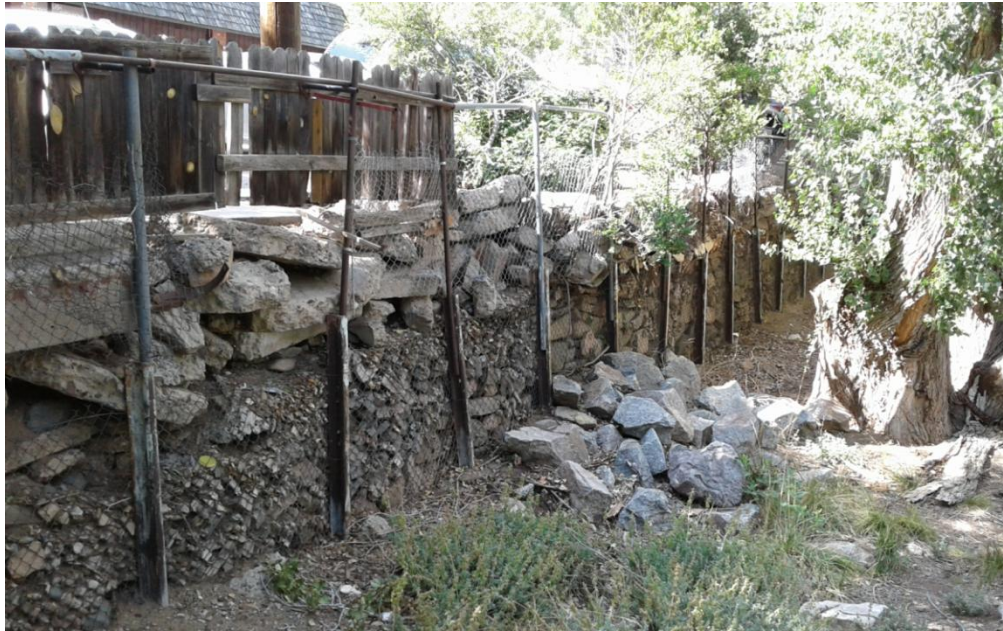
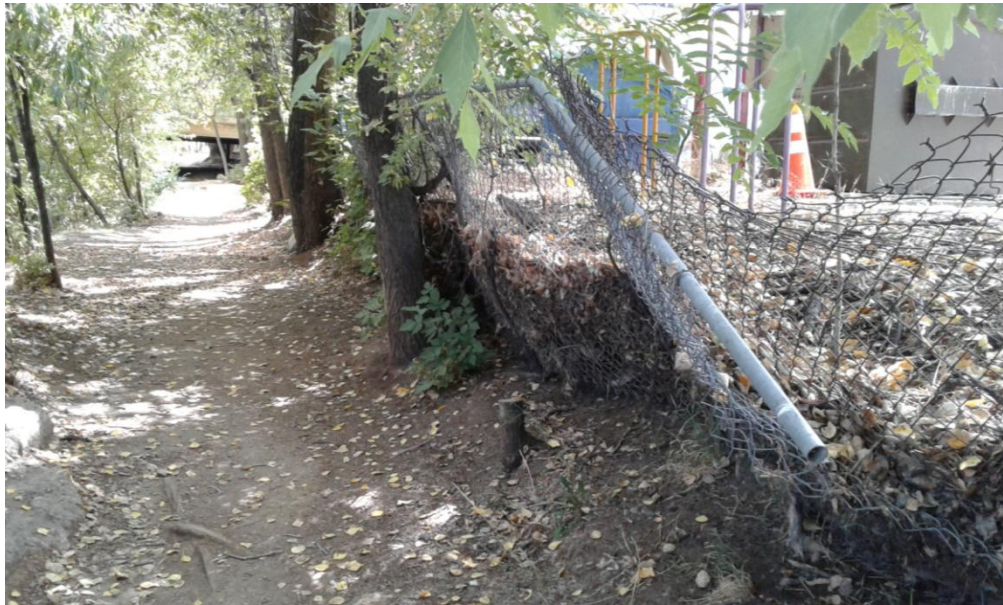
There are fences and retaining walls along the outer edge of the corridor throughout most of the project area, including low and high rock walls, chain link fencing, masonry walls, wood fencing, tall concrete retaining walls, and a few are very attractive, historic rock walls (Figure 20). Most are in good repair; however, a few chain link and wire mesh fences that are acting partially as retaining fencing are failing and unattractive (Figure 17).

Figure 17. Two examples of fencing that are deteriorating.

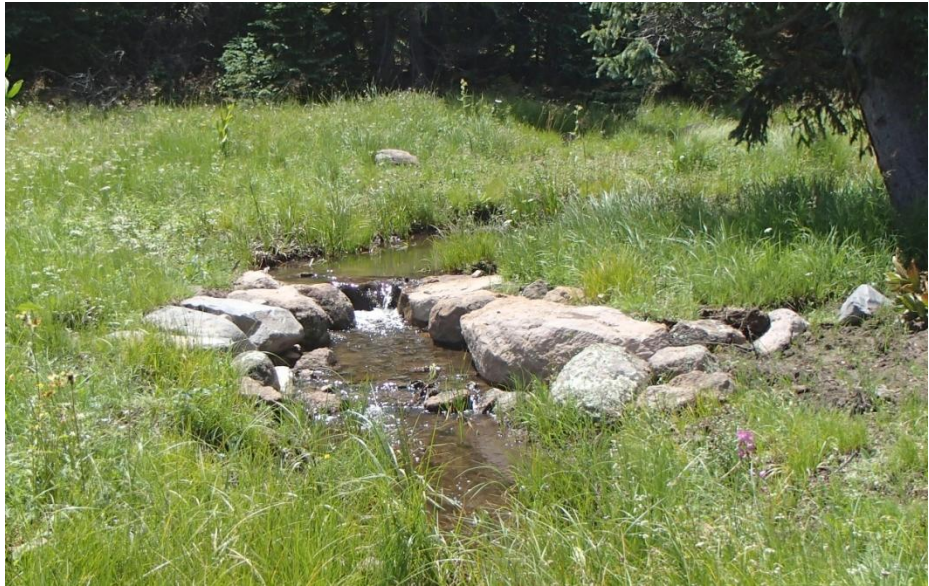
Figure 18. Cross Vane Weir example.

This cross vane weir protects the stream gradient and defines the active channel dimensions.

Cross vane weirs will need to be designed specifically for each location. However, they need not be built all at one time, but can be constructed in smaller groups or singly to provide protection in a shorter reach of stream.

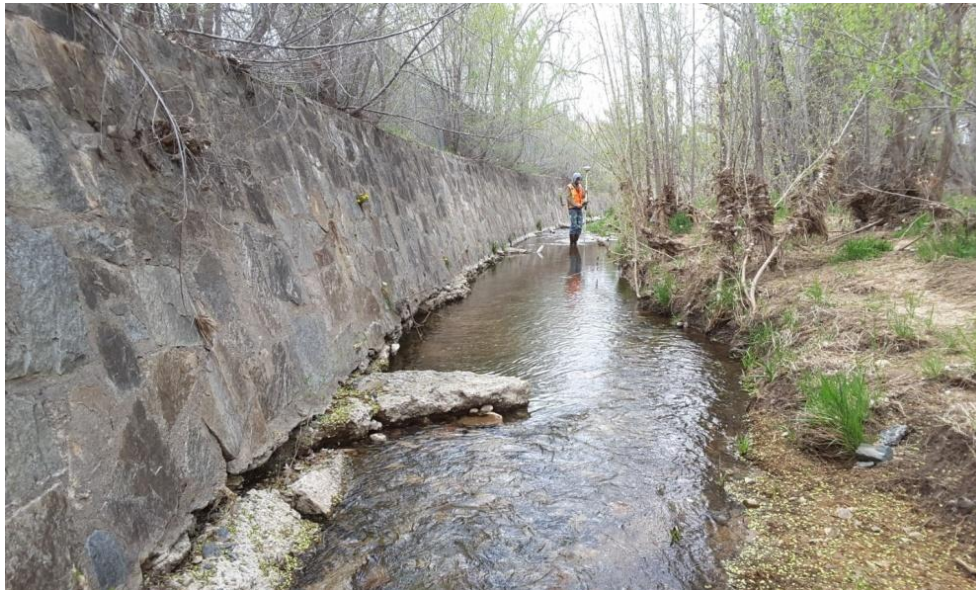
The rock wall between Carleton Street and Goodwin Street is being undermined by erosion, which has also resulted in a narrowed channel through this section with an elevated floodplain. This wall is old enough to require clearance with the State Historic Preservation Office prior to work. We recommend adding grade control to prevent further incision as well as placing toe rock protection along the base of the wall and a few rock vanes to deflect flows away from the wall. This will help to preserve the wall in place without damaging it. The floodplain should be lowered through this section, which will also remove the excessive amount of small trees near the bank. And the channel could be pulled away from the wall slightly, which will help relieve some of the stress on the wall. The disturbed bank and floodplain should be planted with grasses and shrubs for erosion protection.

Figure 20. The foundation of the wall is being undermined.

Where the active channel runs along the retaining wall, grade control should be added to prevent further downcutting. The disturbed areas should be seeded with native grasses and planted with willows and other shrubs. There is also a section where the existing trail is entrenched and during high flows the entrenched trail will channelize flows, which could eventually cause extensive erosion on the trail. The entrenched trail should be repaired to the same grade as the surrounding floodplain.

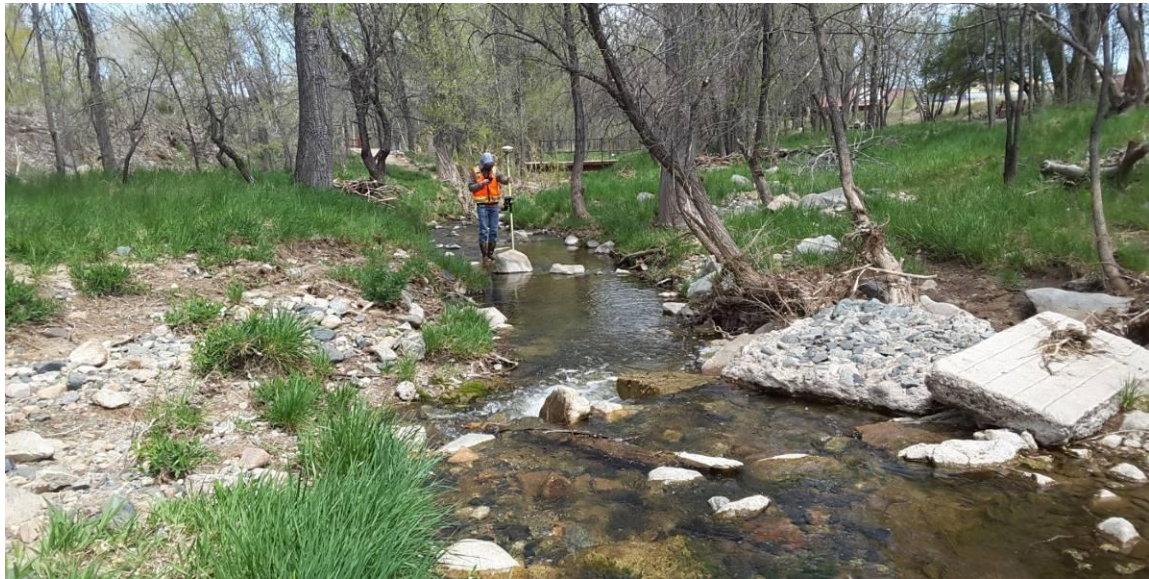
Figure 21. Concrete debris in channel.

There are several locations throughout the project area where there is concrete and other debris within the active channel that is unattractive and should be removed.
